**US Army Corps  
of Engineers**

USACERL Technical Report FE-95/04  
November 1994

# **Improving Central Heating Plant Performance at the Defense Construction Supply Center (DCSC)**

## **Advanced Operation and Maintenance Methods**

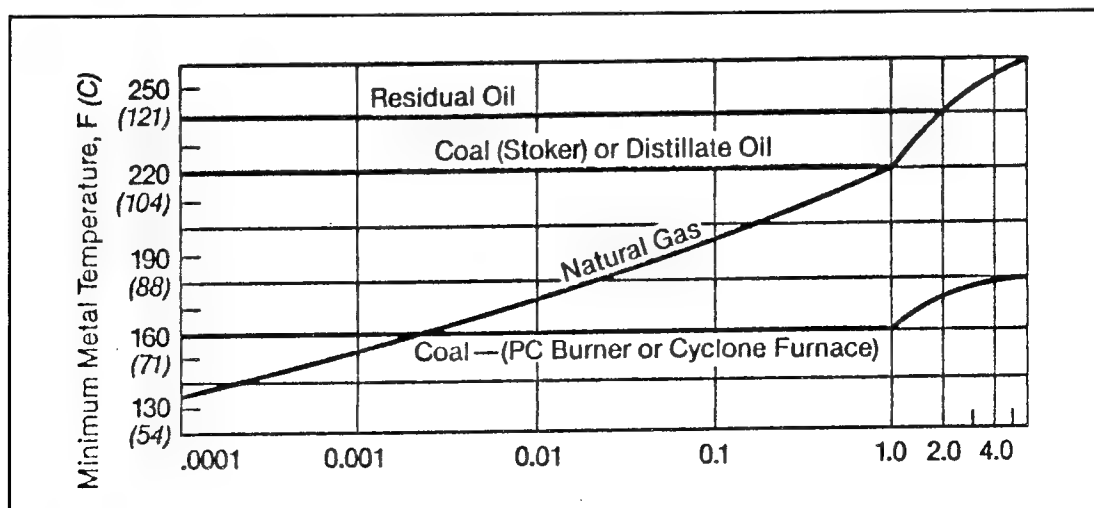
Figure 4. Relationship between sulfur in coal and acid dew point.

Broken discharge wires are caused by corrosion fatigue resulting from frequent operation below the flue gas acid dew point. Figure 4 shows the relationship between sulfur in coal and acid dew point. For test conditions of about 1 percent sulfur coal and 5 percent moisture flue gas, the acid dew point is 287 °F ( $^{\circ}\text{F} = [^{\circ}\text{C} \times 1.8] + 32$ ). The incoming temperature should be about 90 °F above the acid dew point to prevent

corrosion throughout the ESP. The ESP's walls will be much cooler than the center of the gas stream so the inlet gas temperature should be about 377 °F.

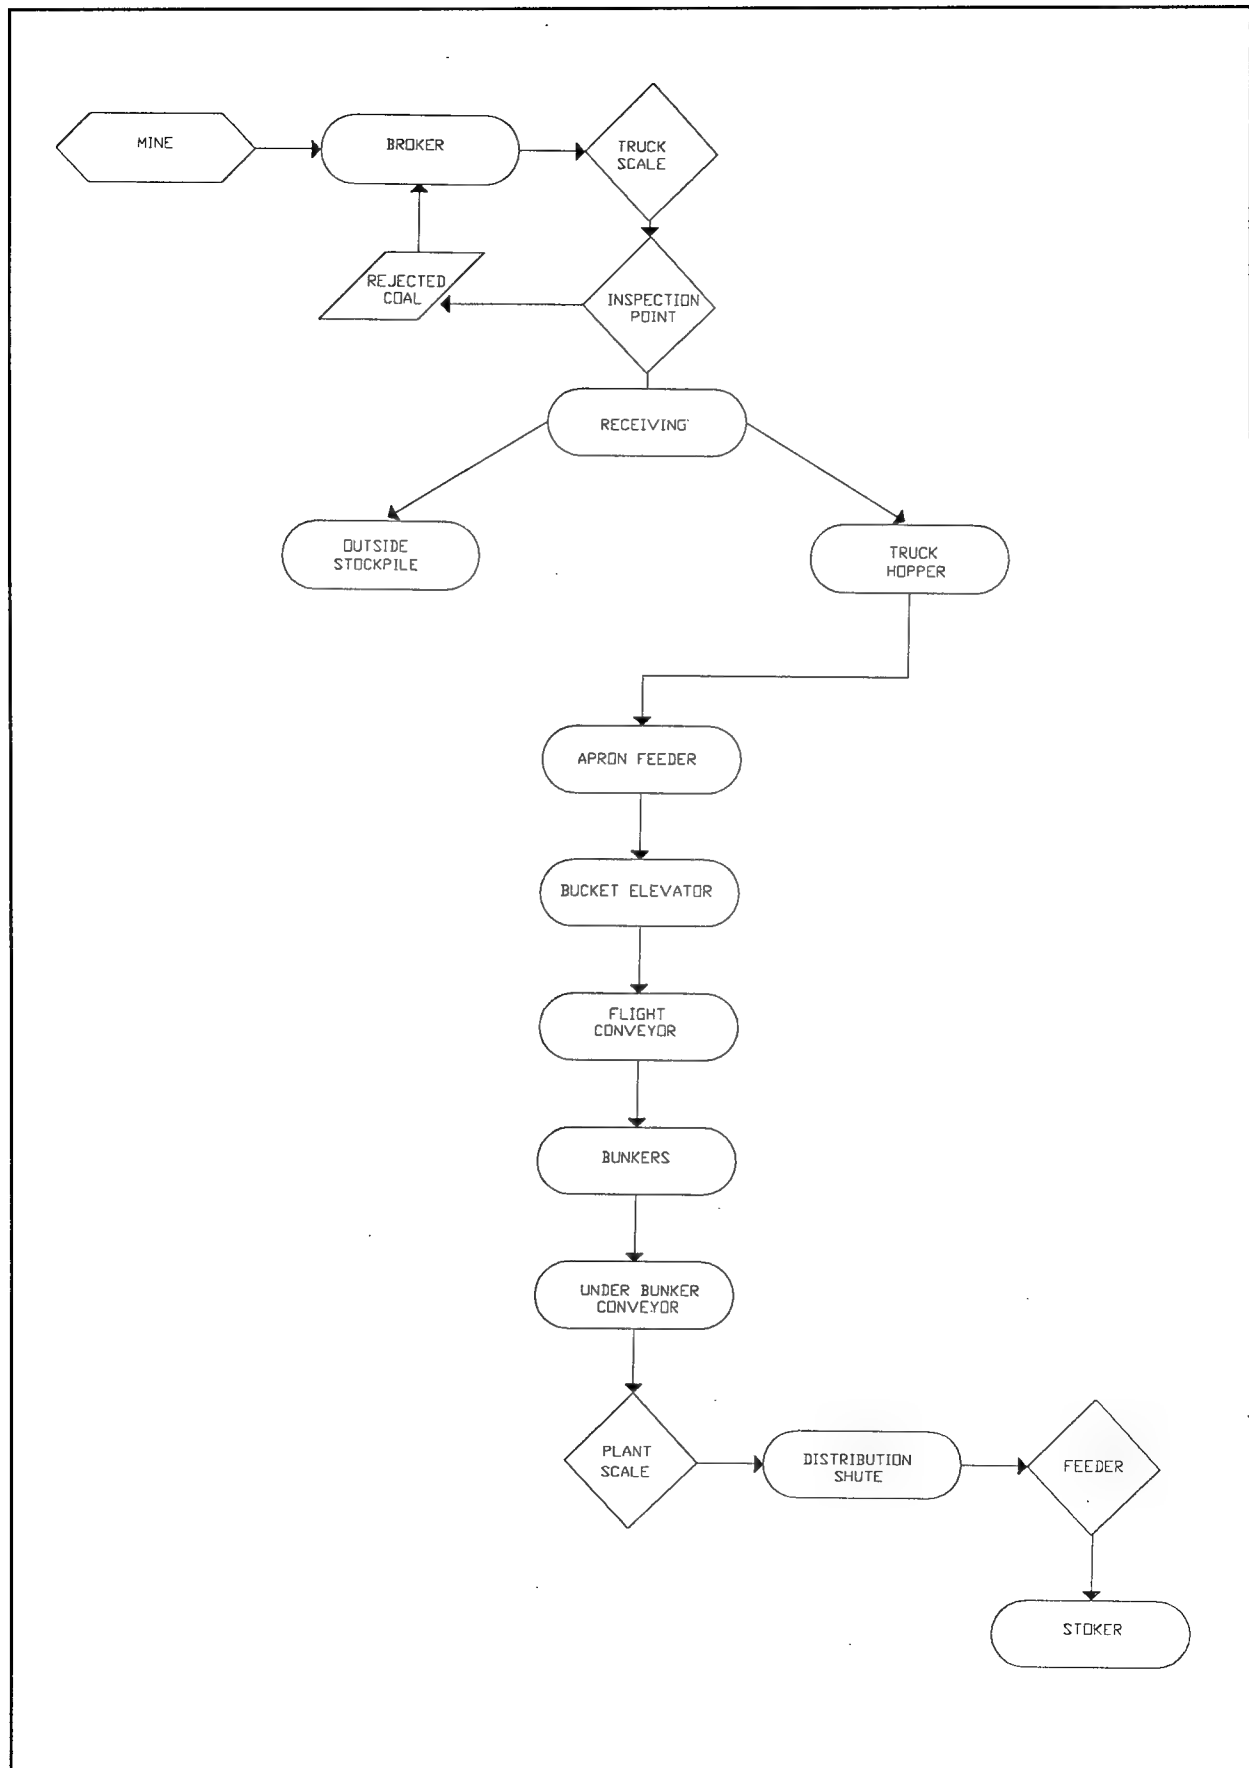
Figure 5. Schematic of DCSC coal storage and handling system.

Coal is normally delivered to the central heating plant by semi-trucks equipped with hydraulic dump beds for unloading. Coal is normally dumped near the outside stockpile, where DCSC personnel use a front end loader to shape and compact the stockpile.

This procedure is not good practice for bituminous stoker coal for several reasons. Piling the coal creates fines by agitation and segregates the coals. As discussed earlier, fines do not burn well in spreader stokers. Segregation occurs because large pieces of coal tend roll to the outside and lower edges of the pile creating areas of small pieces and areas of big pieces. In other words, the coal sizes are not equally distributed in the pile. The coal size distribution delivered to the feeder hopper must meet the specifications required by the stoker.

Second, large piles (over 10 ft tall) tend to spontaneously combust because, as the coal in the middle of the pile oxidizes, the resulting heat cannot dissipate through the thick pile. The heat builds up until the coal begins to burn. DCSC personnel noted that occasional fires are not unusual.

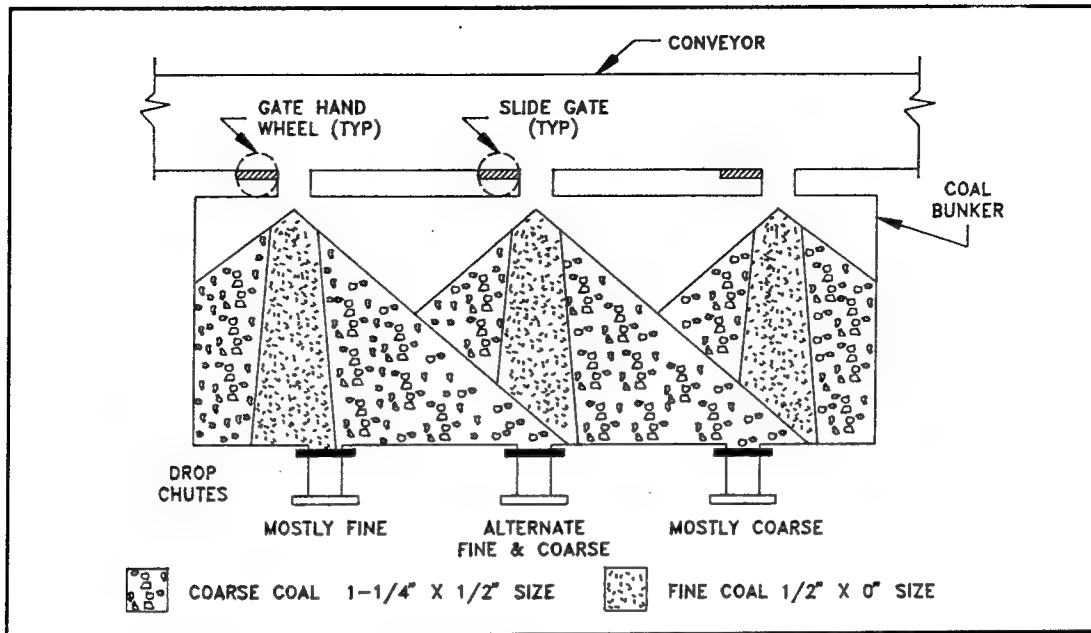
Figure 6. Schematic showing coal segregation.

The DCSC standard operating procedure for filling the bunkers was to leave all the slide gates on the flight conveyor open. This procedure causes segregation to occur in the overhead bunker. Figure 6 shows a schematic representation of this segregation. The bunker area under the first slide gate was filled first, creating a cone shaped pile up to the slide gate. With the first slide gate closed off with coal, coal would fill the area under the second slide gate. This procedure was continued until the bunker was filled.

This segregation causes slugs of fines and large coal to be sent to the HTWG feeders instead of the required homogenous size distribution. This will cause poor distribution of coal on the stoker grates, resulting in poor combustion and high particulate emissions. As discussed earlier, poor size distribution at the stoker feeders was identified during the USAEHA tests.

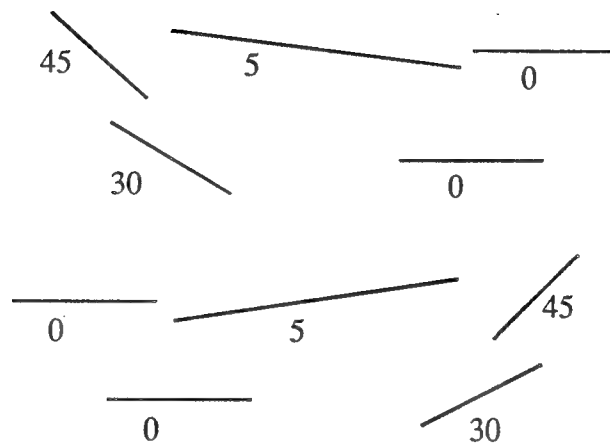
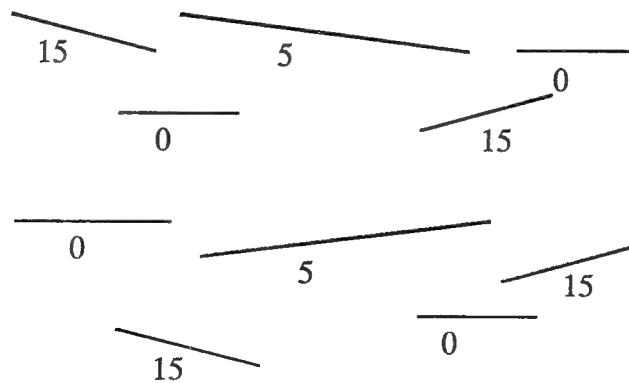
PADDLE ANGLE ARRANGEMENT  
(ALL FEEDERS)

**Coal feeders.** All three HTWGs have Model B Riley Spreader Stoker feeders. A careful inspection of HTWG no. 2 and 3 feeders showed that they were in excellent mechanical condition. No replacement of parts was necessary. However, observation of the lateral coal distribution on units no. 1 and 3 indicated that modification of some of the distributor paddle angles was needed to improve lateral coal distribution over the grate area. Figure 10 shows the existing paddle angles followed by the suggested arrangement. The improvement in coal distribution over the grate area will permit complete combustion of the fuel with less excess air.

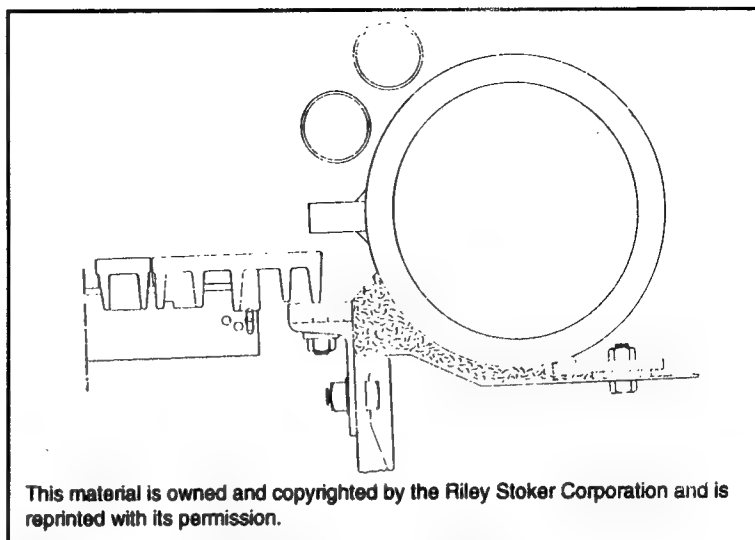
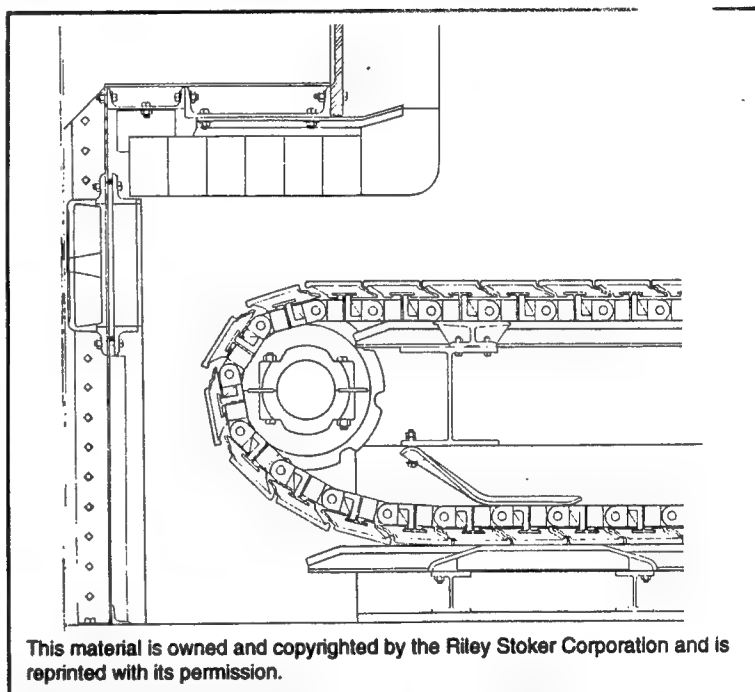
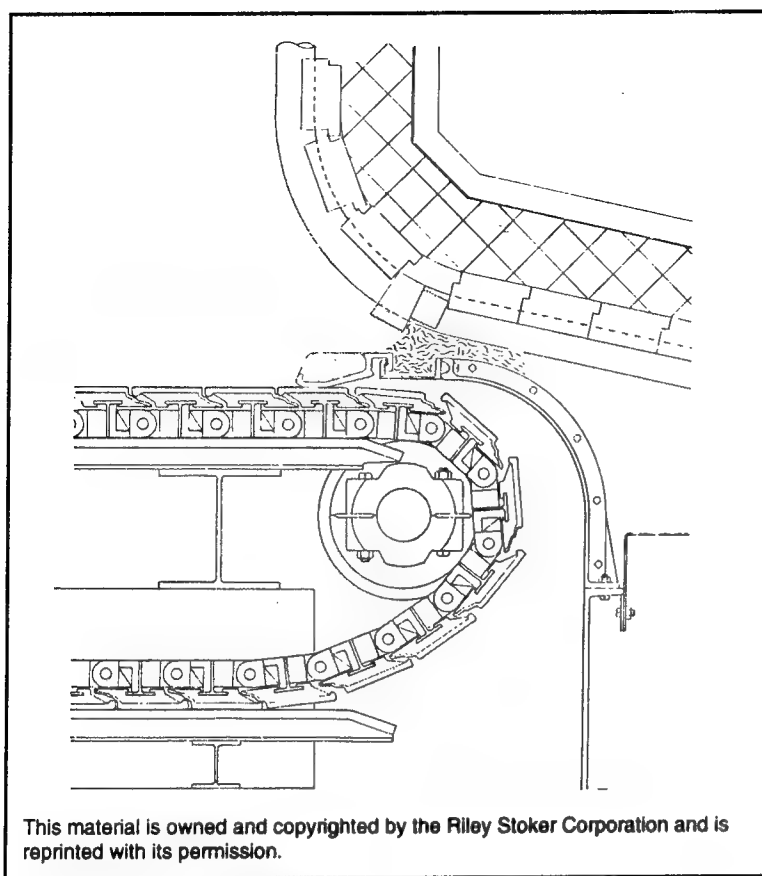
The grate clips on HTWG no. 3 showed definite overheating distress. The clips were humped and beginning to bind on the "TEE" bars (grate racks). To alleviate this, one 1-in. grate clip was removed from each rack (1 in. = 25.4 mm). The grate clip growth was undoubtedly due to operating with too thin an ash bed on the grate surface or running "clinkers" (inadequate excess air). If there is any further deterioration due to overheating, this grate surface will have to be replaced within 1 year. The rear overgrate air seal castings on this unit were similar to those on HTWG no. 2. The castings were wearing and subject to heat deterioration, but were still sound.

The side air seals were adequate and the stationary castings were in excellent condition. The sealing clips were in very good condition. However, the clips did not make firm contact with the

stationary castings due to the "TEE" bars being bent upward slightly. To correct this, the bars could be bent downward the next time the grate clips are replaced.

The front air seals were in good condition. There are no broken or missing castings and contact between moving and stationary members was correct.

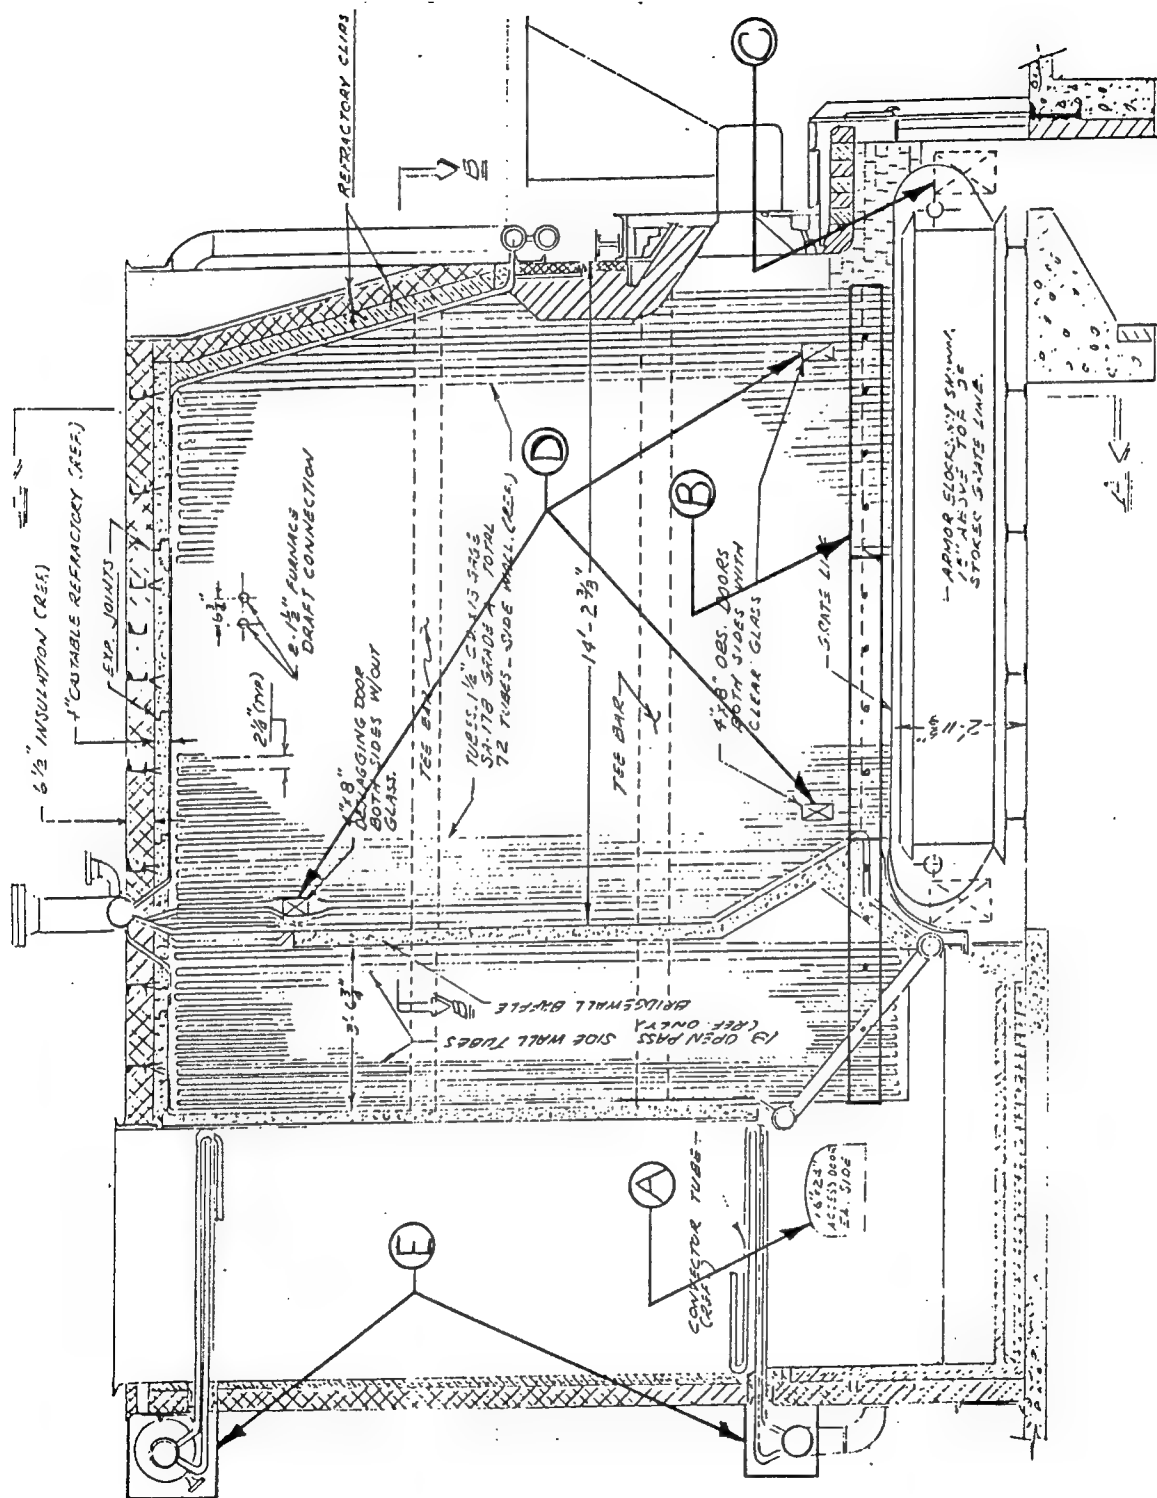
Figure 15. Location of HTWG leaks.

On HTWG no. 2, one of the overfire air lines passing through the hopper was defective. The 2-1/2 in. pipe was broken at a pipe flange and was separated by about 2 in. Because of this leak, about 50 percent of the air supplied by the fan was escaping into the last pass hopper.
